Manhole Inspection Summary

Manhole # S53M__048MH

Insp Date: **4/7/08 11:43 AM**

Location Address: **823 decker**

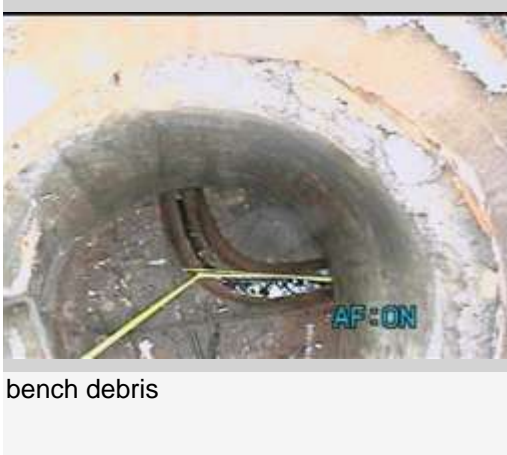
misc

bench debris

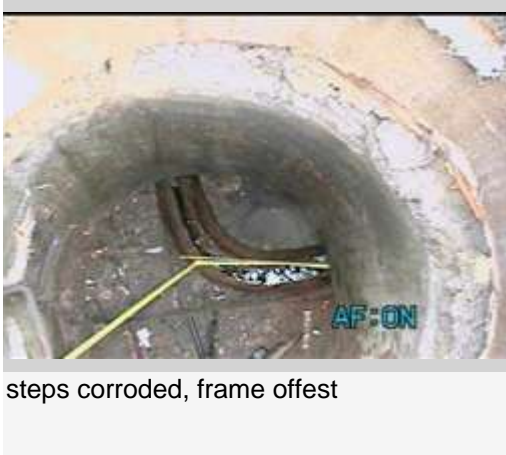
Defect 1

Frame Offset: **2** (in.) Condition: ☐ Sound ☐ Cracked ☐ Leaks

Steps Count: **4** Missing: **0** ☒ **Corroded**

steps corroded, frame offest

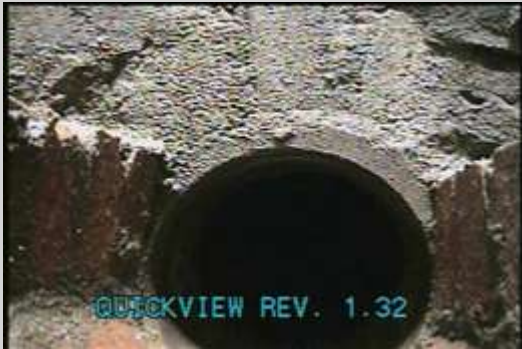
12 O'Clock Outflow

8 in. Circular Gravity Sewer
Pipe Out @ 12 O'Clock

Invert Depth: **8.25** (ft.) Flow Characteristics: **Slow**

Infiltration: **None** Pipe Seal Cond: **Unknown**

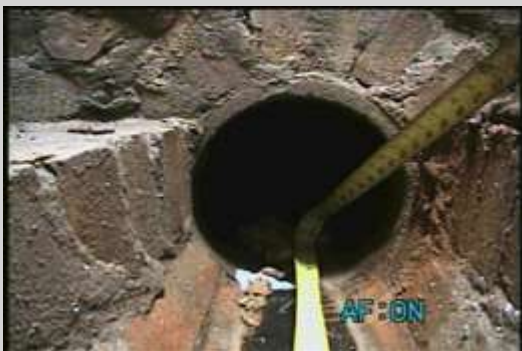
3 O'Clock Inflow

8 in. Circular Gravity Sewer
Pipe In @ 3 O'Clock

Invert Depth: **8.10** (ft.) Flow Characteristics: **Slow**

Infiltration: **None** Pipe Seal Cond: **Unknown**
